METALLURGICAL LABORATORY

FAILURE ANALYSIS CASE STUDY

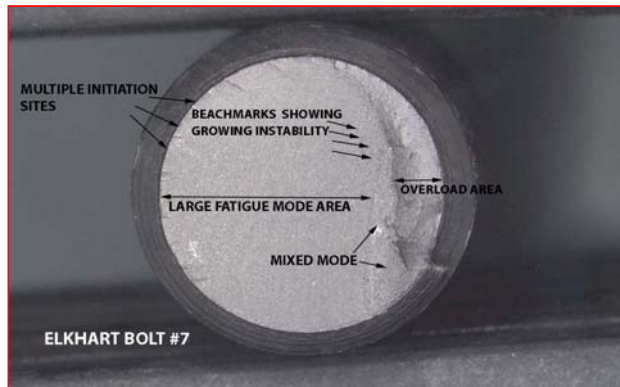
Fracture surface overview

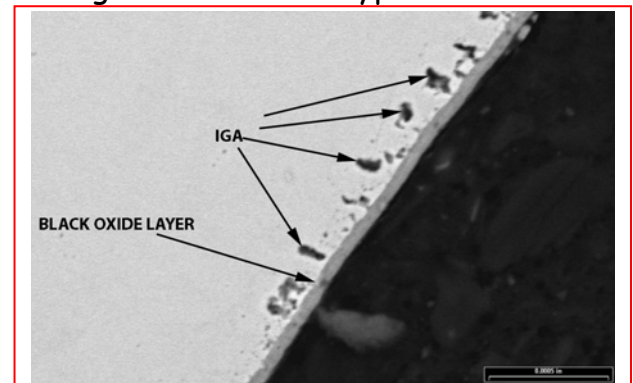
Intergranular Attack-type corrosion

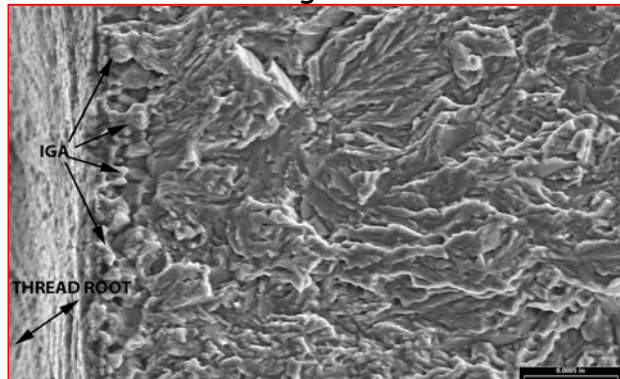
SEM section showing IGA at thread root

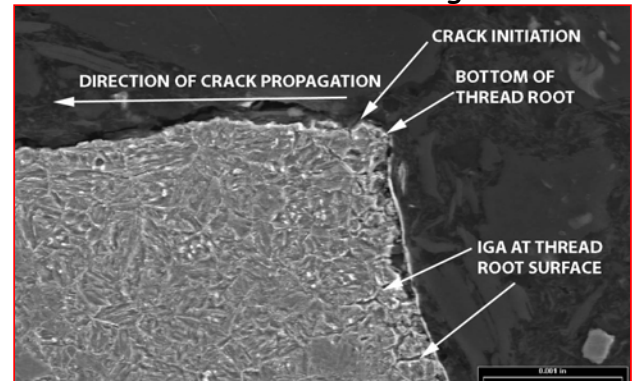
SEM fracture surface showing IGA.
