## METALLURGICAL LABORATORY FAILURE ANALYSIS CASE STUDY

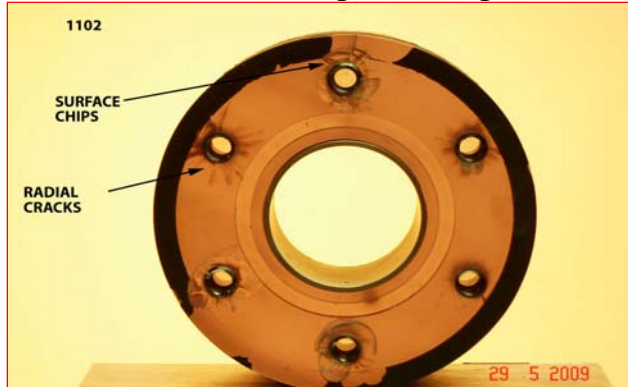
Description	Cracking of Polycarbonate base around Helicoil® inserts.
Problem	Cracks around inserts discovered by customer upon receipt could compromise durability.
Analysis	SCC cracks were caused by Chlorine compounds in the cutting fluid. Driving forces for crack propagation most likely came from residual as well as imposed stresses.
Resolution & Recommendations	Eliminate cutting fluids containing halides and esters. Use FPI and/or sectioning to qualify first pieces.

Backlit section showing radiating cracks

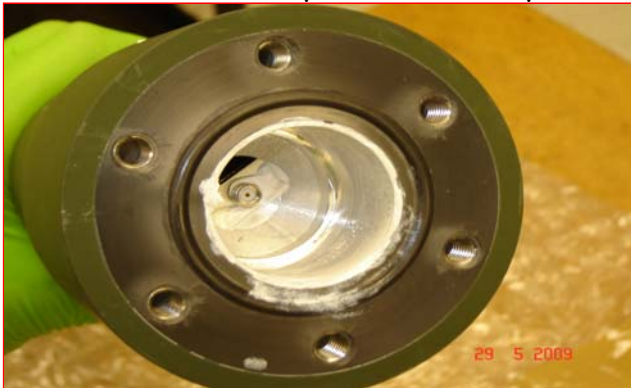
Cracks seen upon disassembly

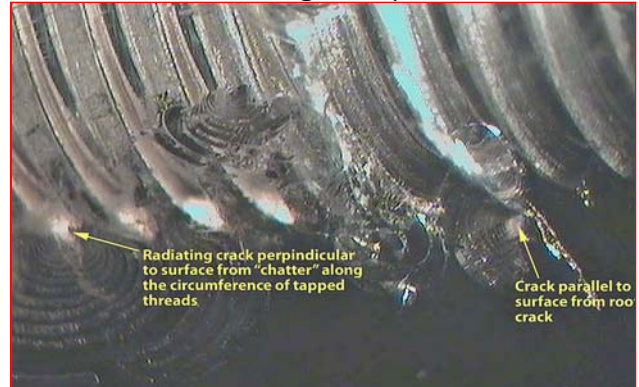
Cracks emanating in 2 planes

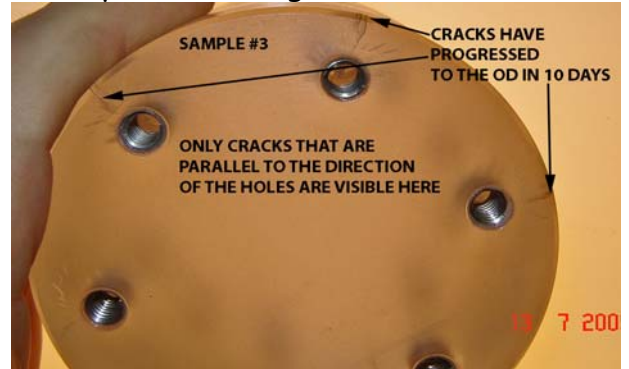
Cracks duplicated using coolant with chlorine
