Metallurgical Laboratory Failure Analysis

MET 06-[REDACTED]

Date: [REDACTED]
Customer: [REDACTED]
Part Name: [REDACTED]
Part No.: [REDACTED]
Drawing No.: [REDACTED] [REDACTED]
NSN: [REDACTED]
Serial Nos./Production Lot: [REDACTED]
Manufacturer: [REDACTED]
Material and Treatment: Shield Assembly Silver Braze, Brazing Operation
Prepared By: [REDACTED]
Investigation: Metallurgical Evaluation of Braze Quality

Three braid/adaptor end-connector shield assemblies (one for each serial number) were longitudinally sectioned to reveal the mating surfaces. The sections cleaned ultrasonically to remove sectioning debris, mounted in conductive plastic mounts, and prepared using standard metallographic techniques to a final finish of 1 μm diamond. The polished sections were analyzed by scanning electron microscopy and energy dispersive spectroscopy. In order to ensure that metallographic artifacts did not influence the interfaces and their analysis, the interfaces and microstructures were evaluated for evidence of damage. Regions of good interfacial bond were noted as well as clear dendritic patterns within the braze regions indicating that the metallographic preparation did not adversely infl

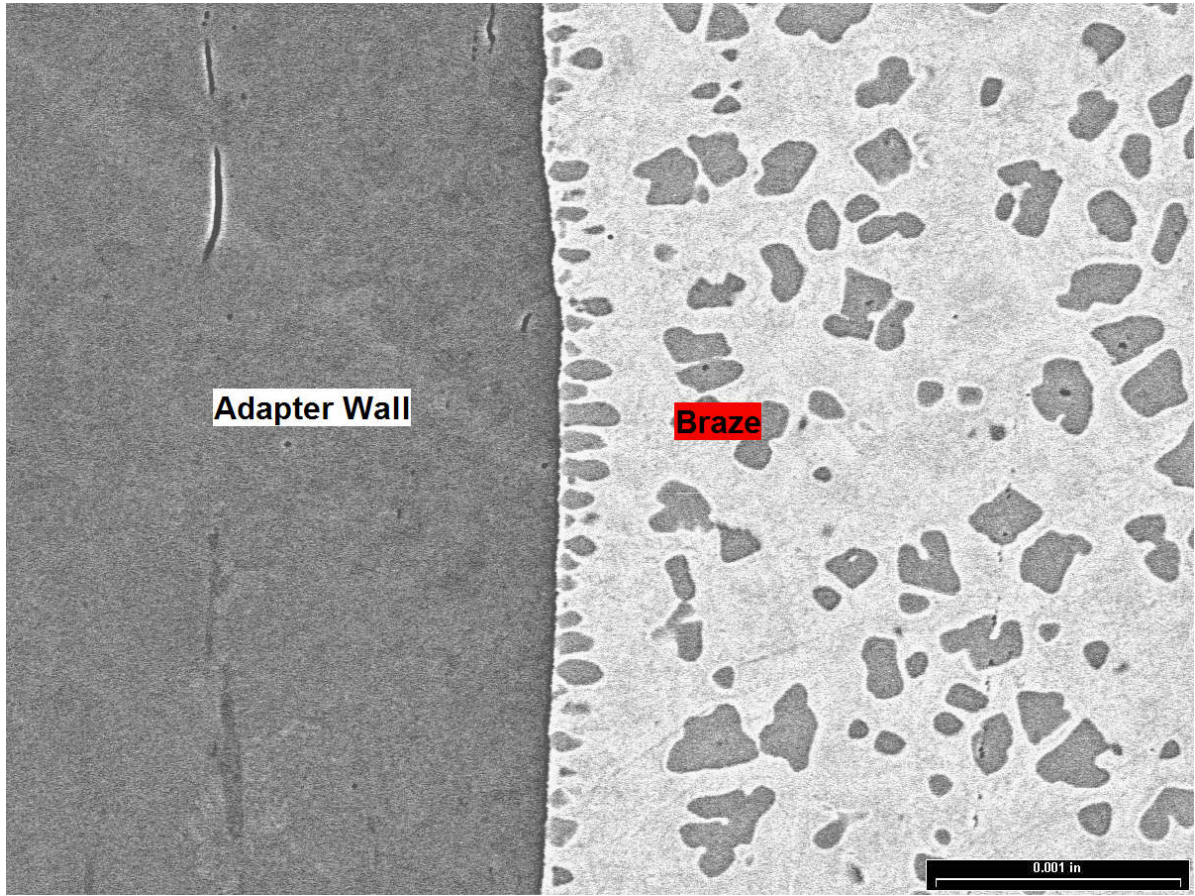
Figure 1 Region of good interface bonding between the braze and the adapter wall. Braze also shows copper-rich dendrites in a silver-rich matrix with denuded zones around the primary dendrites. Indicates a high quality of metallographic preparation.

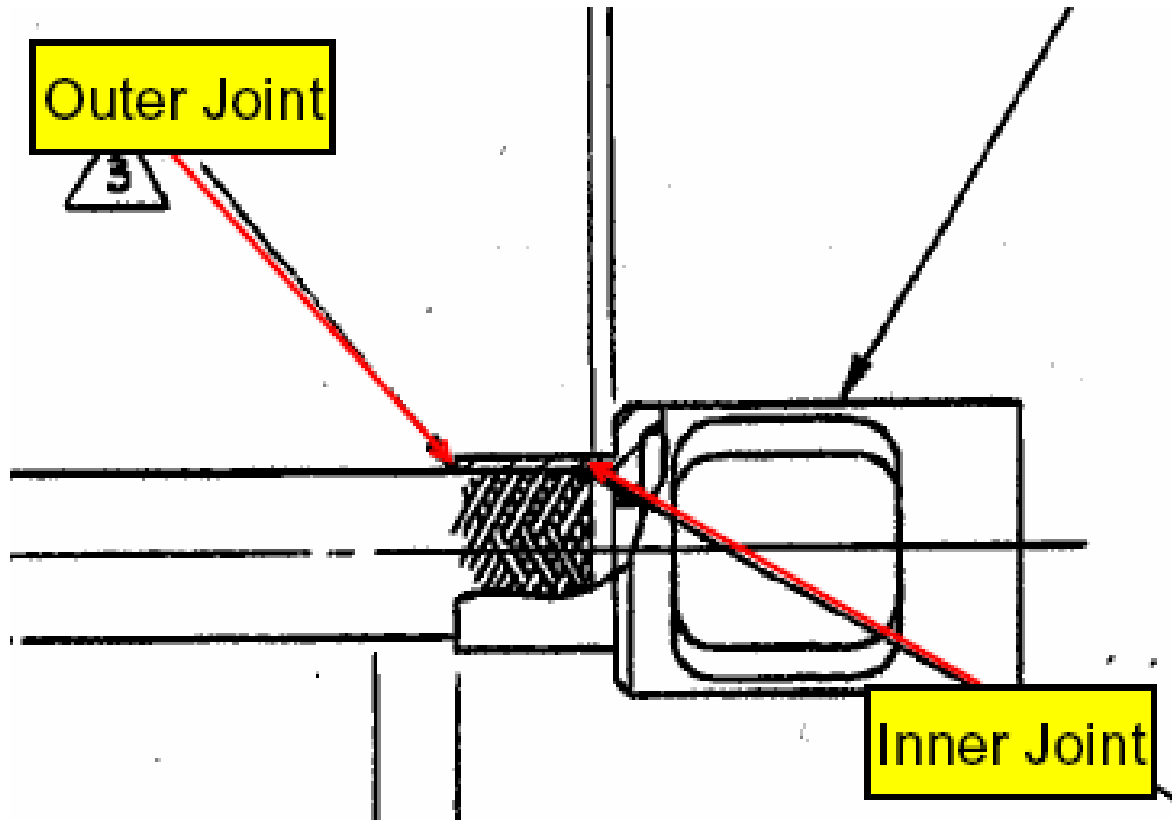
The adapter-side end (interface) was termed as the inner joint while the braid-side end was termed the outer joint, as shown in Figure 1.

Figure 2 Nomenclature used in the metallurgical analysis descriptions.

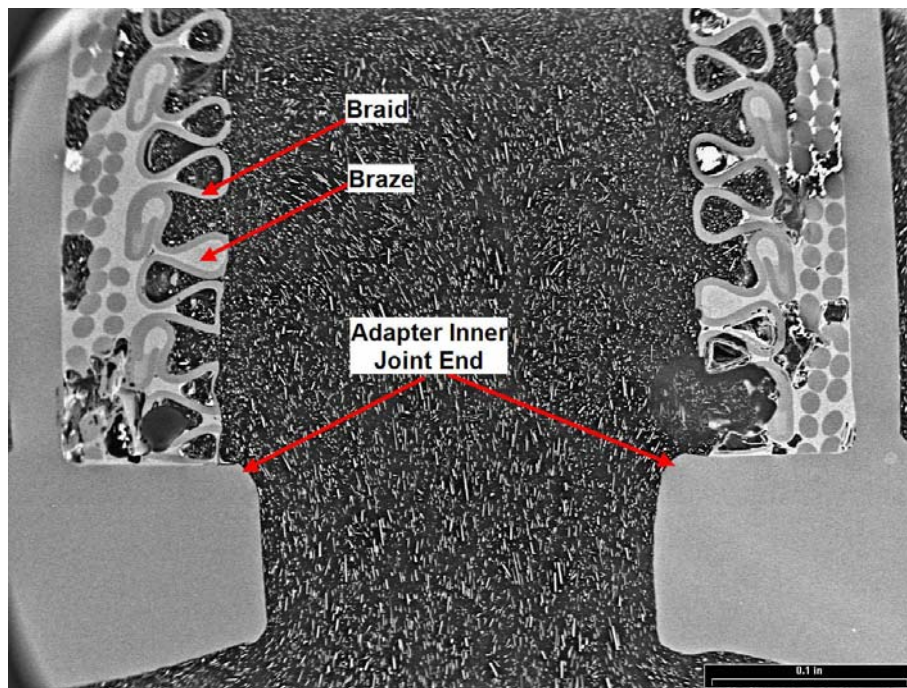
1. The amount of braze was insufficient for the joint volume.
2. Braze material was missing from a significant length of the joint, particularly near the outer end.
3. At the braze/adapter interface, there were regions of disbond, indicating deficient metallurgical bonding.

Figure 3 Overview of inner joint.

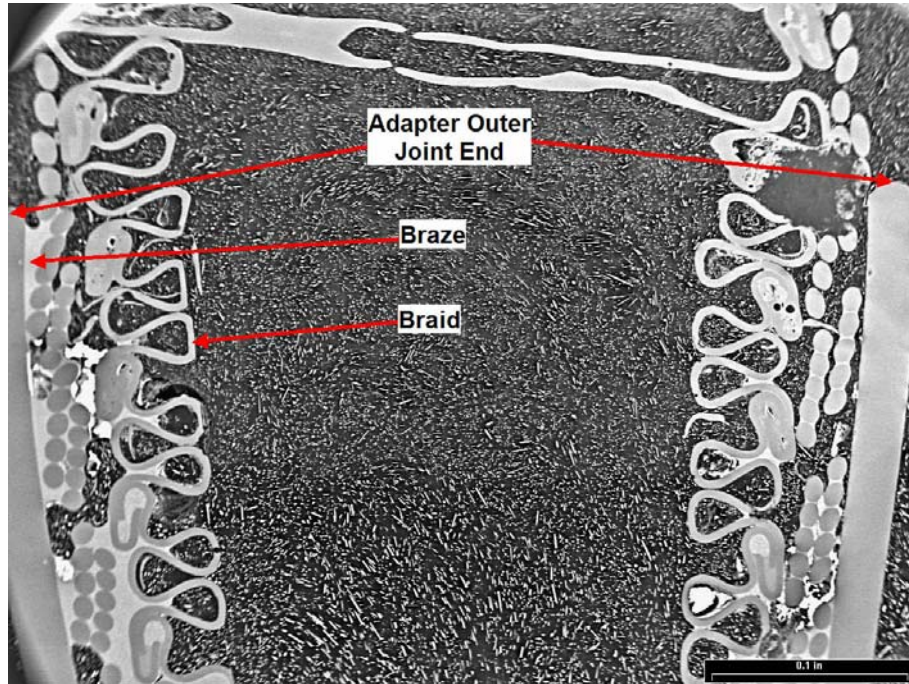
Figure 4 Overview of outer joint.

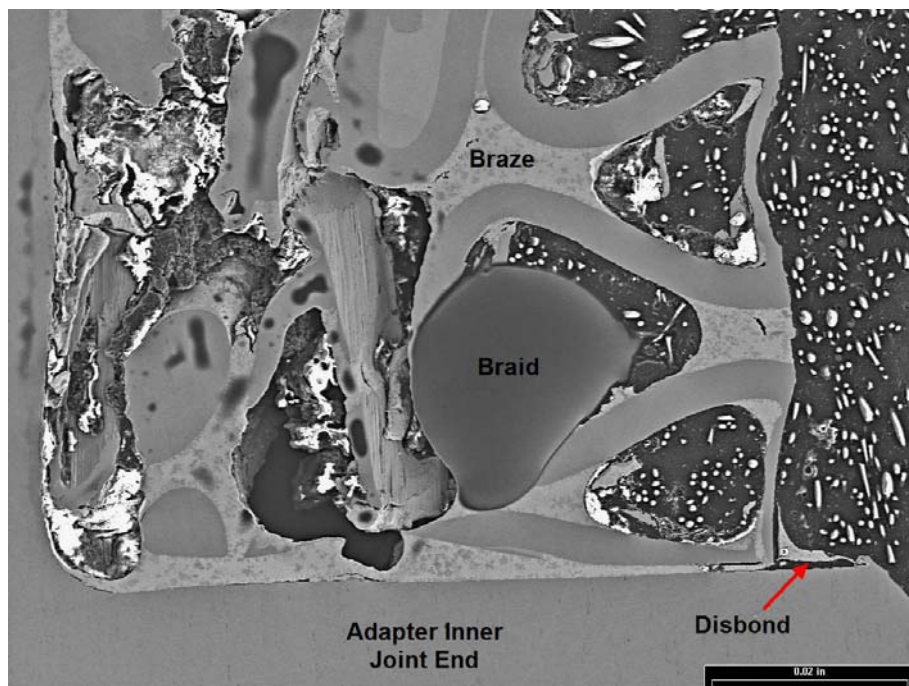
Figure 5 Inner joint detail.

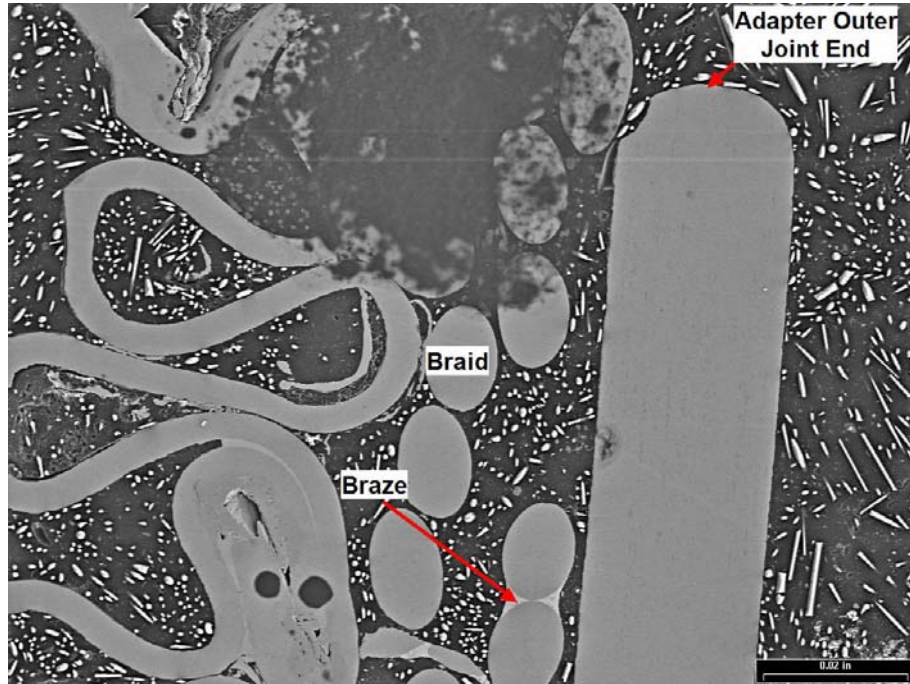
Figure 6 Outer joint detail.

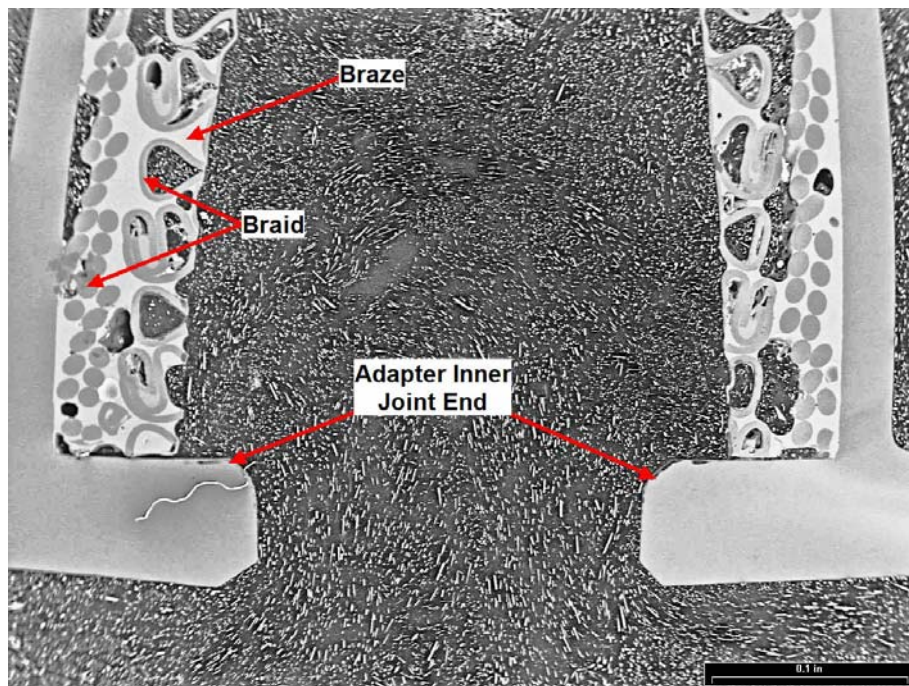
1. The amount of braze was insufficient for the joint volume.
2. Braze material was missing from a significant length of the joint, particularly near the outer end.
3. At the braze/adapter interface, there were significant regions of disbond, indicating deficient metallurgical bonding.

Figure 7 Overview of inner joint.

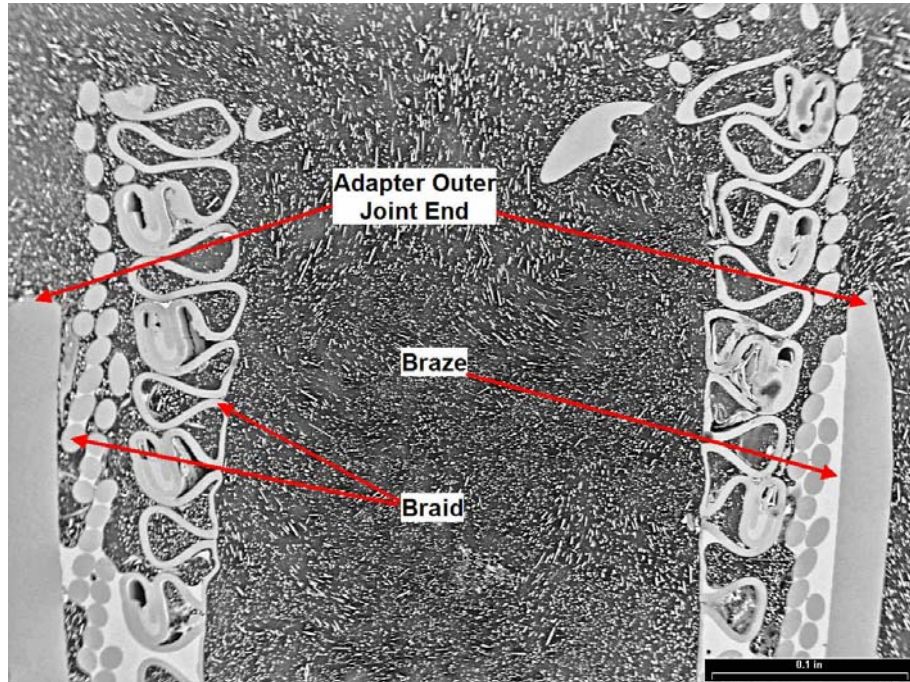
Figure 8 Overview of outer joint.

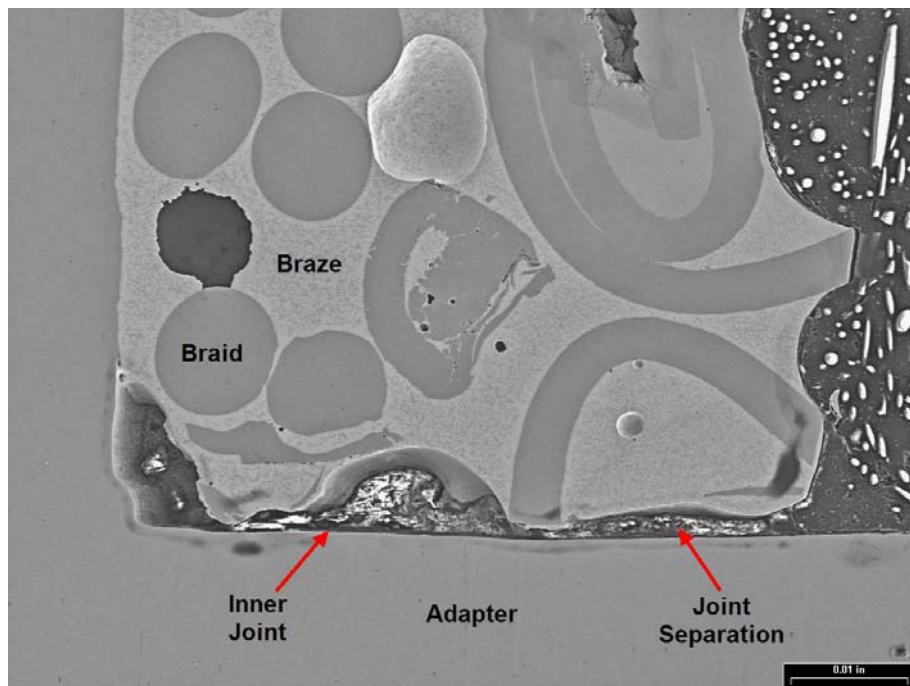
Figure 9 Inner joint detail.

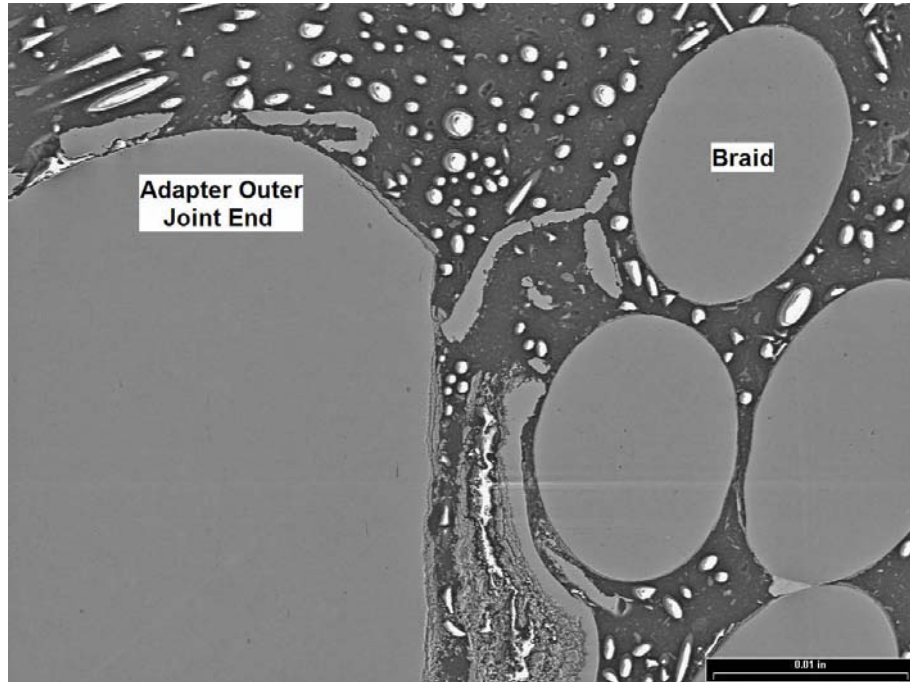
Figure 10 Outer joint detail.

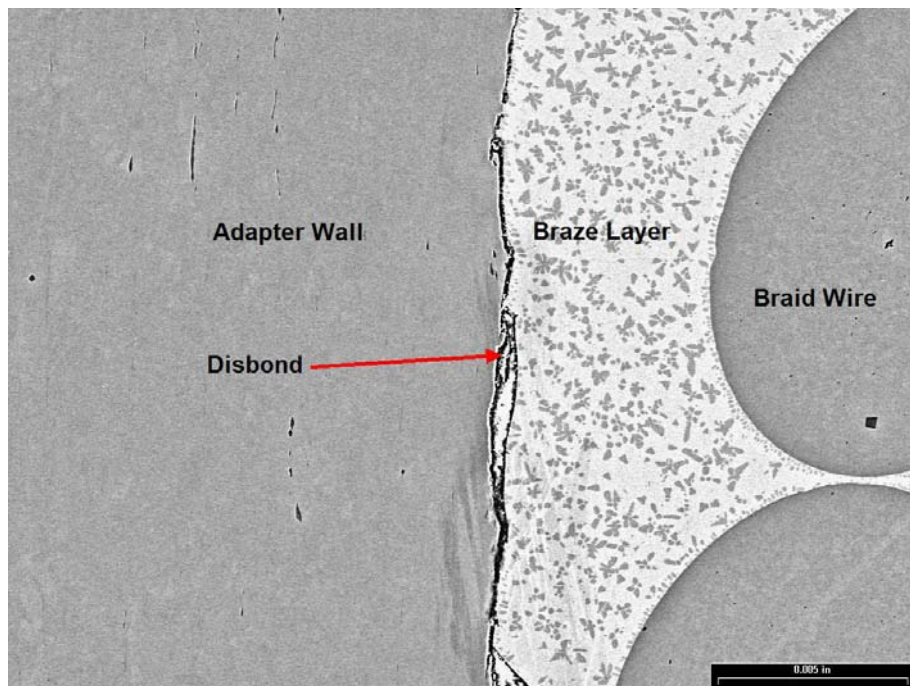
Figure 11 Interface disbond detail.

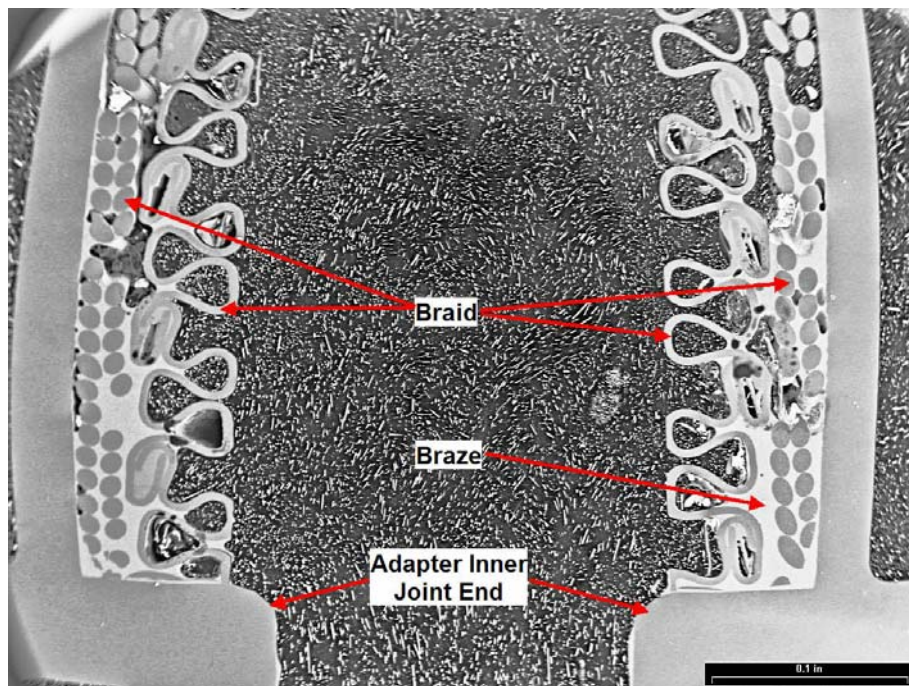
1. The amount of braze was insufficient for the joint volume.
2. Braze material was missing from a significant length of the joint, particularly near the outer end.
3. At the braze/adaptor interface, there were significant regions of disbond, indicating deficient metallurgical bonding.

Figure 12 Overview of inner joint.

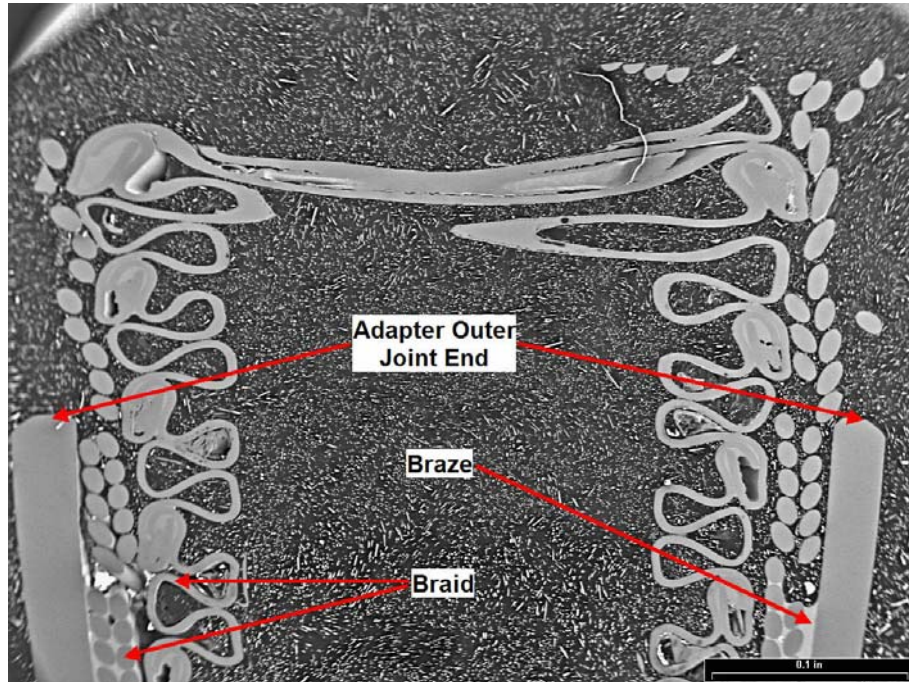
Figure 13 Overview of outer joint.

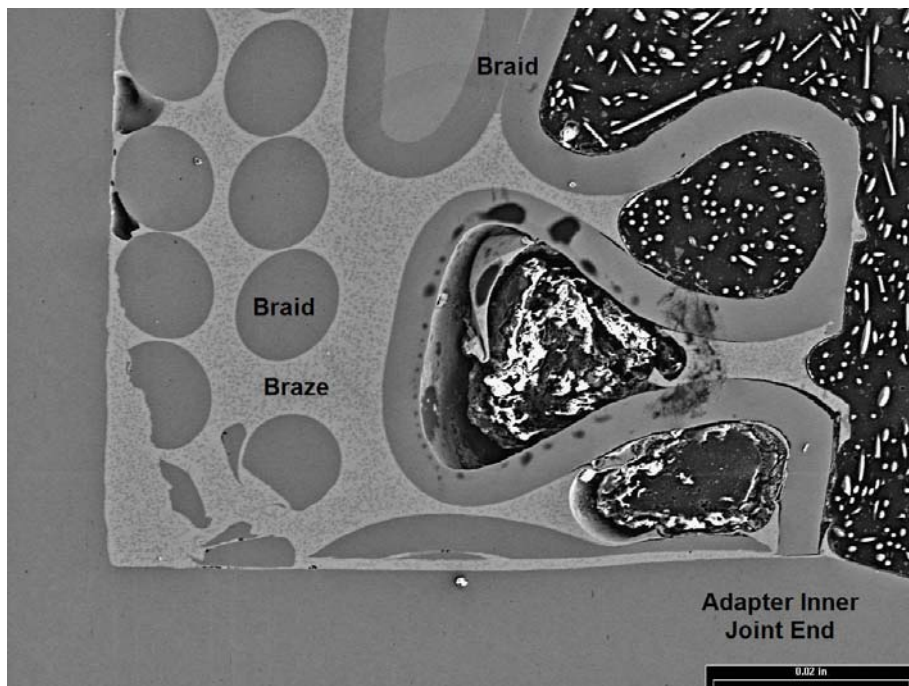
Figure 14 Inner joint detail.

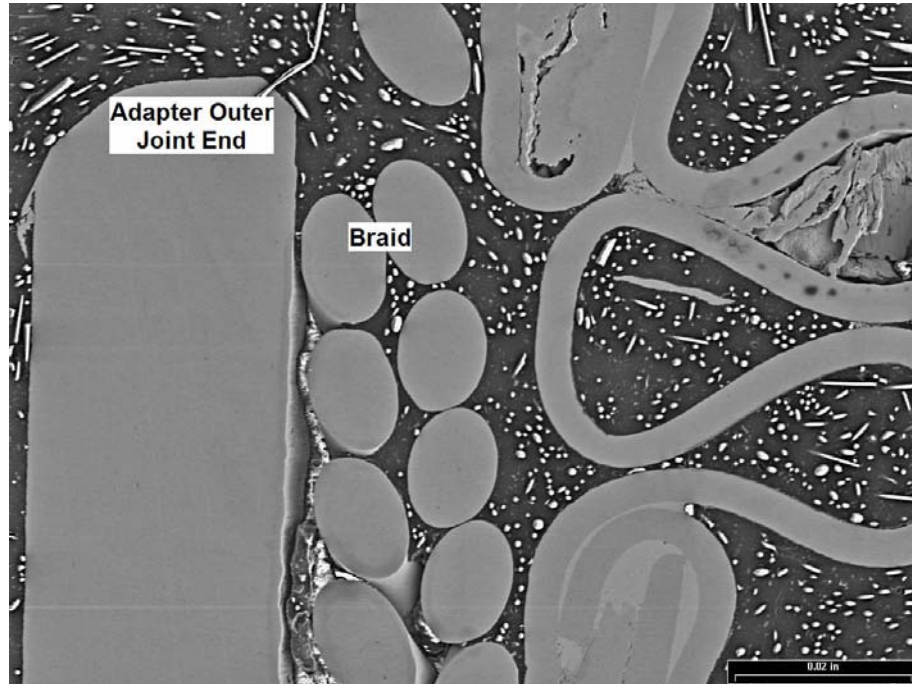
Figure 14 Outer joint detail.

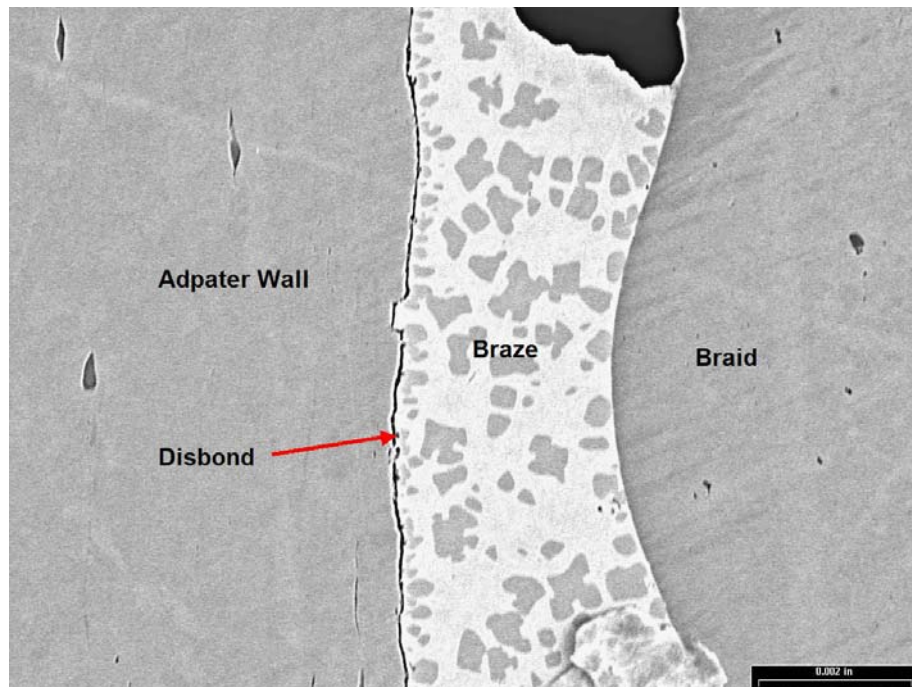
Figure 15 Interface disbond detail.
