METALLURGICAL LABORATORY FAILURE ANALYSIS CASE STUDY

Description	Failure in Al alloy A356-T6 aircraft nose landing gear casting
Problem	Nose landing gear failure raised a concern of a fleet-wide problem
Analysis	Nose landing gear failed because of fatigue cracking in a low damage tolerant microstructure (interconnected Si needle network)
Resolution & Recommendations	Correct T6 heat treatment improved ductility. EC conductivity measurements could be used to non-destructively screen the fleet for improper heat treatment (brittle microstructure)

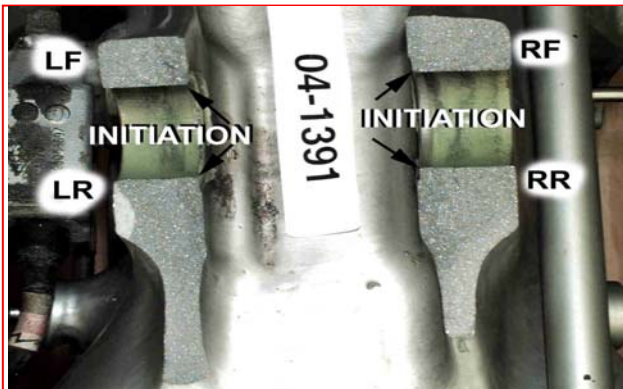
Fracture Location Overview

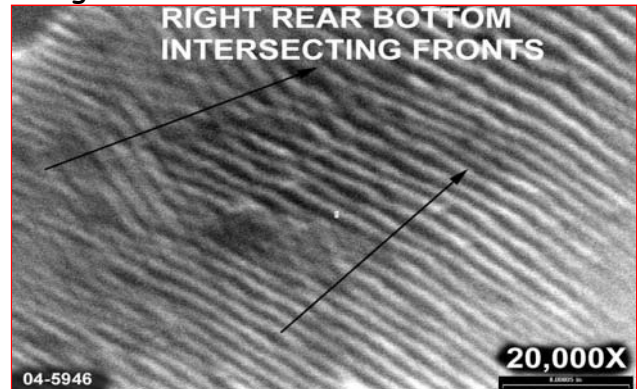
Fatigue Striations

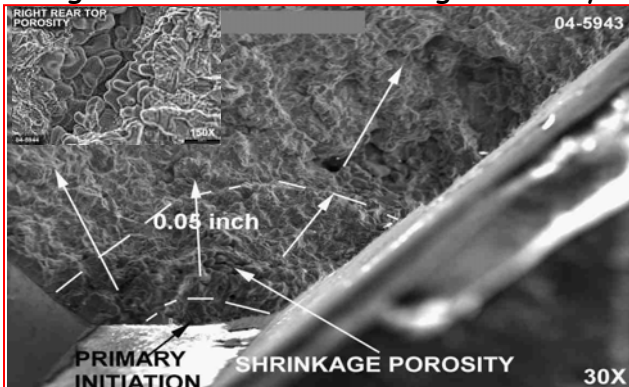
Fatigue Initiation at Shrinkage Porosity

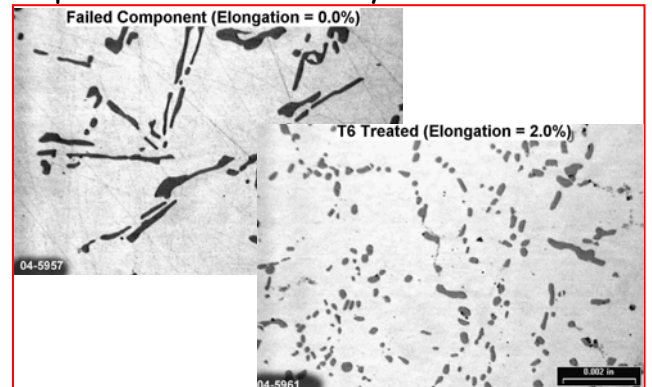
Improvement in Ductility
